**US Army Corps
of Engineers**

Technical Report HL-94-1
May 1995

Demonstration Erosion Control Project Monitoring Program

Fiscal Year 1993 Report

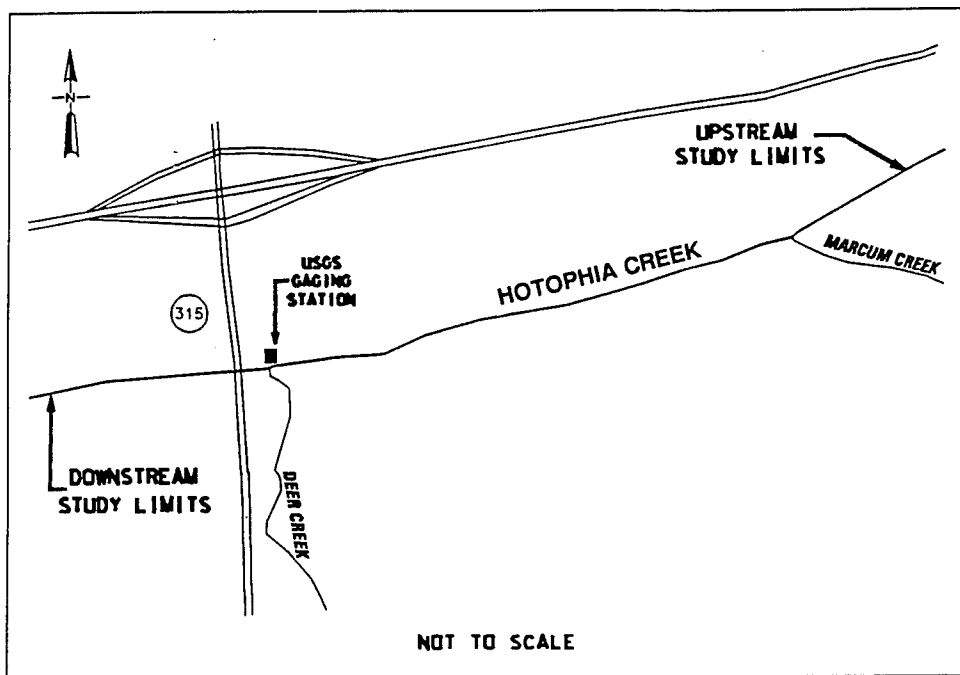
Figure 24. Hotophia Creek, Site 13

Site 13 is located on Hotophia Creek, west of Oxford, MS. As shown in Figure 24, the site encompasses approximately 2 miles of Hotophia and Marcum Creeks and is located on the Sardis quadrangle map T9S, R6W, Sections 1 and 2, and in T9S, R5W, Section 6. The watershed area at the site on Hotophia Creek is approximately 17 square miles. A USGS gauging station is located at the Highway 315 bridge crossing of the creek. The study reach includes the confluences of Marcum Creek and Deer Creek. A low-drop on Hotophia Creek is at the downstream extent, two low-drops are on Deer Creek, a high-drop is located on Hotophia Creek immediately downstream of the Marcum Creek confluence, and a low-drop is located on Marcum Creek. Two additional high-drops, one within the reach and one upstream of the reach, were under construction at the time of the 1993 surveys. WES-installed stream gauging is available at the first high-drop.

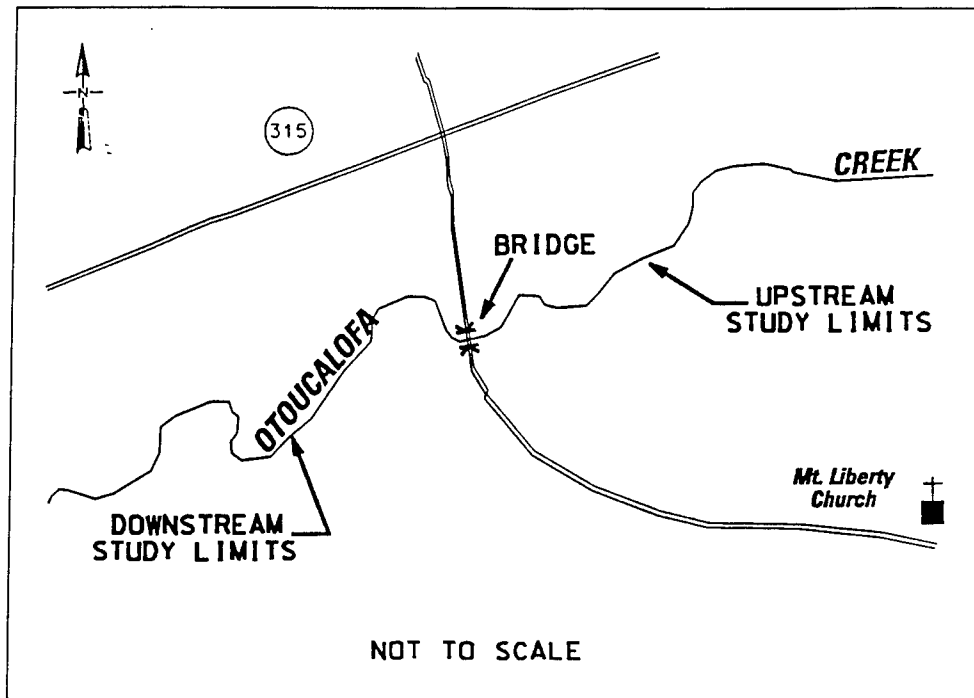
Figure 25. Otoucalofa Creek, Site 14

reach is 4,000 ft in length, 2,000 ft upstream and downstream of the Mt. Liberty Church Road bridge, in T11S, R3W, Sections 4 and 5, of the Water Valley quadrangle map as shown in Figure 25. Watershed area at the site is approximately 41 square miles. No stream gauging is presently available; however, this site will be gauged at the bridge in the future.

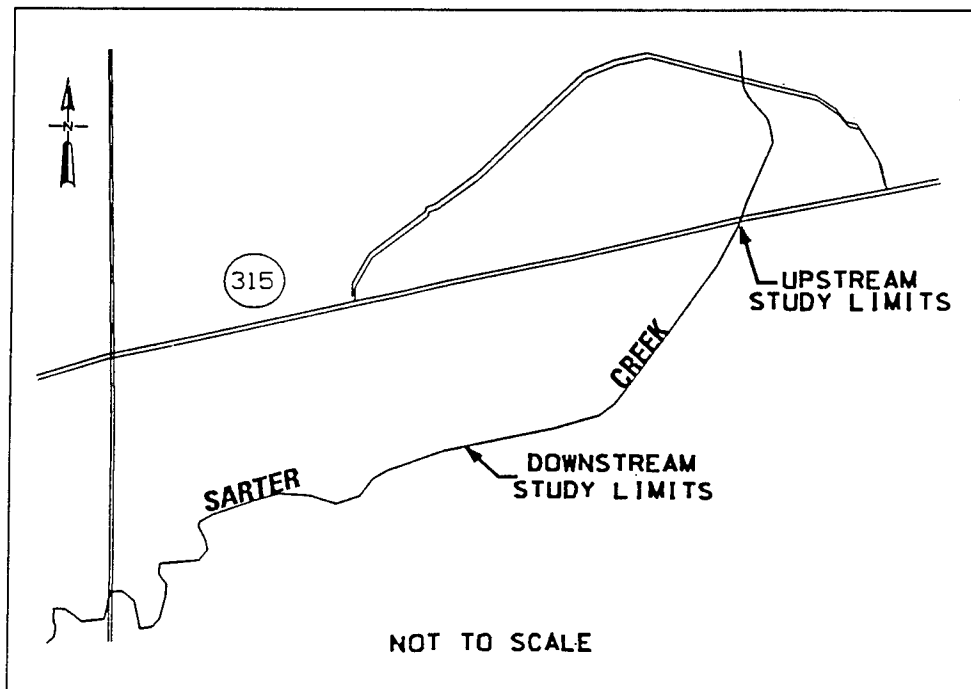
Figure 26. Sarter Creek, Site 15

Site 15 is on Sarter Creek, which is a tributary of Otoucalofa Creek upstream of Site 14. Sarter Creek is located on the Paris quadrangle map and has a watershed area of approximately 6.4 square miles. The study reach is 4,000 ft in length and is almost completely straight as a result of previous channelization, as shown in Figure 26. This site extends downstream of the Highway 315 bridge. The site is unusual in that it had remained relatively unchanged since channelization; however, it is apparent that headcutting affected the reach in 1993.

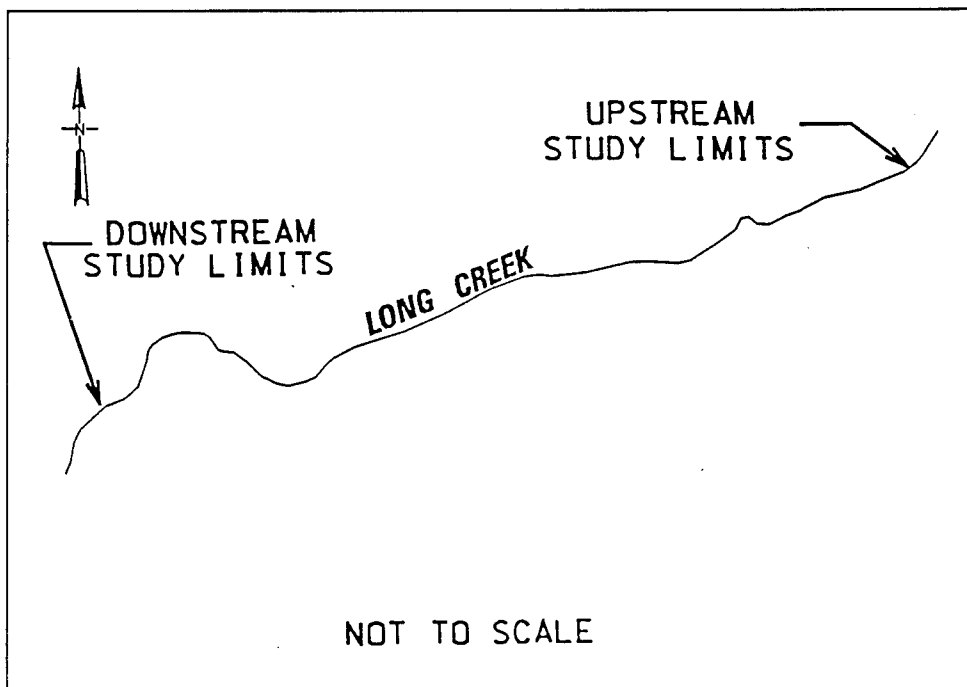
Figure 30. Long Creek, Site 20

Site 20 is located on Long Creek, T10S, R6W, Sections 4, 5, and 8, as shown in Figure 30. The site can be found on the Oakland quadrangle map and has a watershed area of about 11 square miles. Three low-drop structures existed prior to 1991, and the fourth was constructed in 1993 as the downstream limit of the monitoring reach. A fifth structure was constructed in 1993 downstream of the reach. The study reach is approximately 2 miles in length, extending downstream from the eastern boundary of Section 4. The site also includes a reach that has been monitored by the Vicksburg District and includes the bank stability sites reported by Zevenbergen et al. (1990). Portions of this reach are very unstable and are presently incising. The reach downstream of the existing structures has a clay bed that is slowly incising. This clay bed has a very narrow, deeply incised channel along some reaches and was inundated by the structures built in 1993.

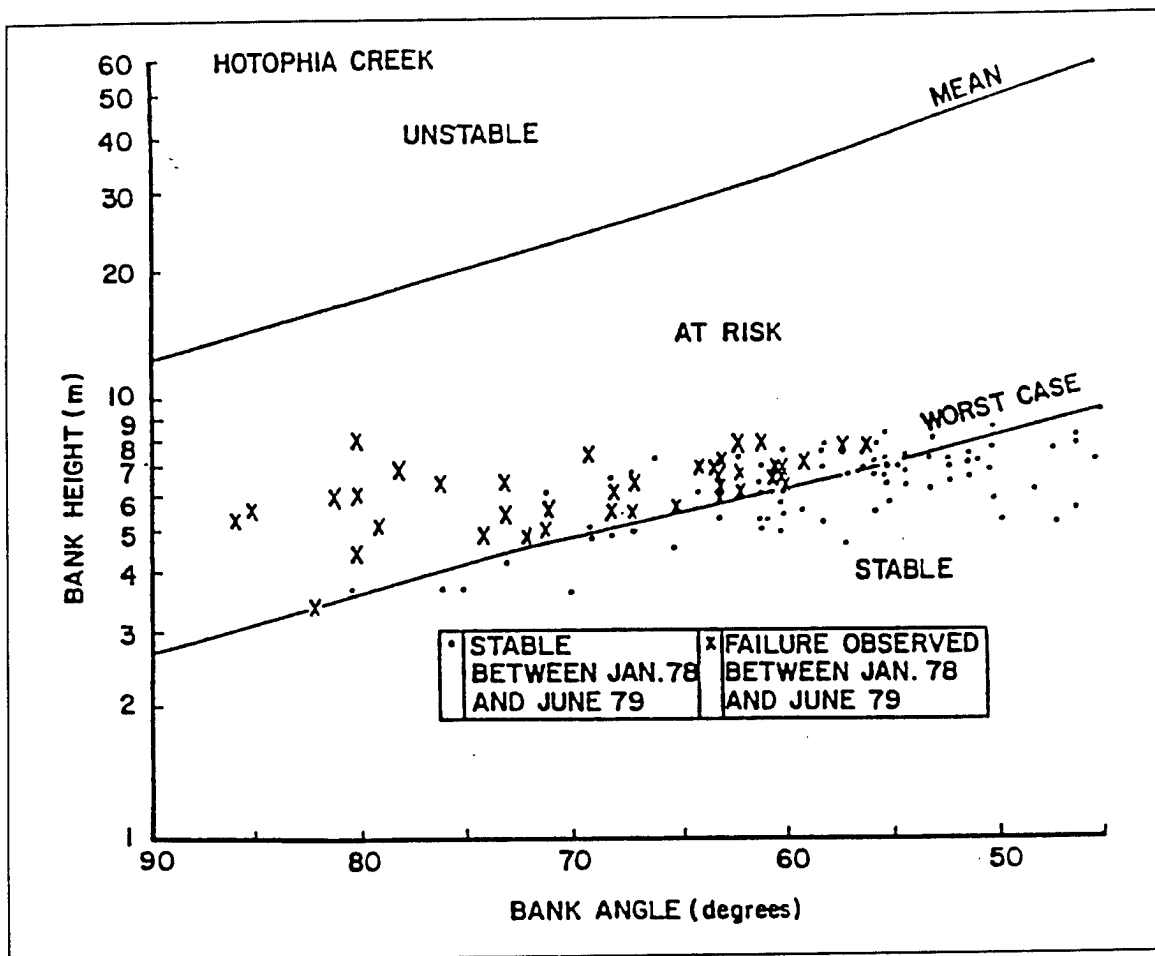
Figure 31. Bank stability graph for Hotophia Creek (Thorne, Murphey, and Little 1981)

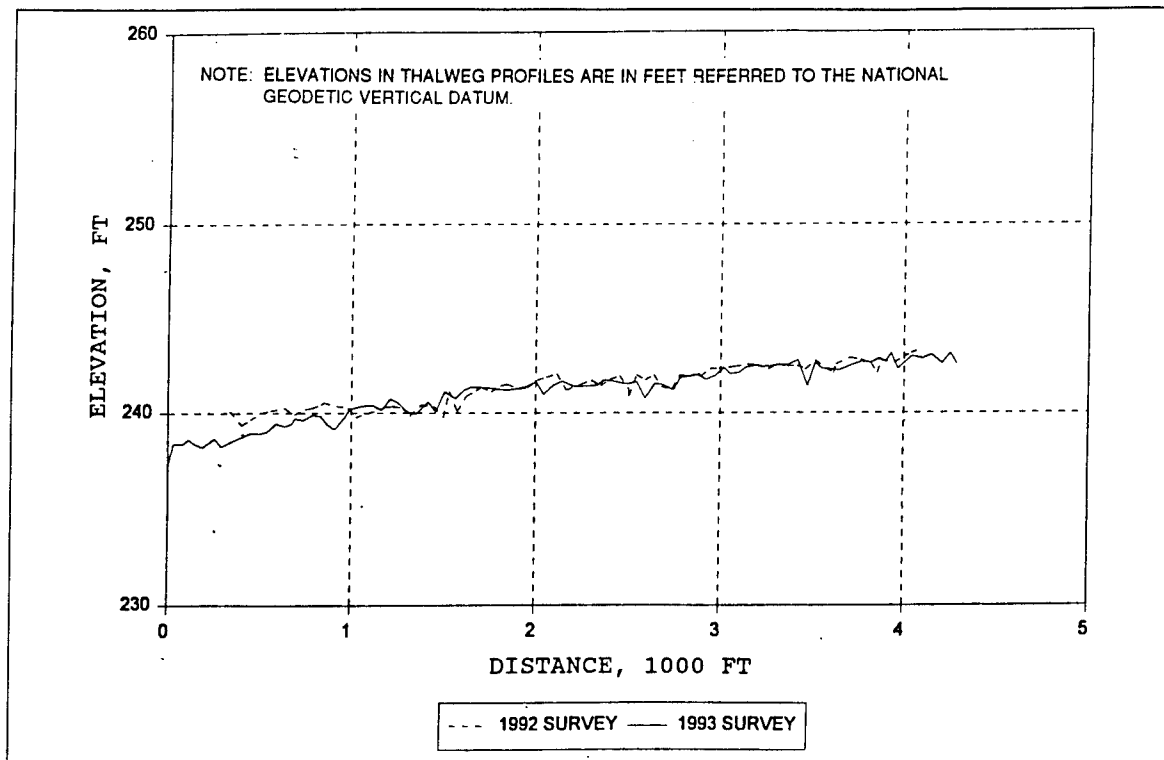
Figure 32. Comparison of 1992 and 1993 thalweg profiles for Abiaca Creek, Site 3

Highway 17 in the upper portion of the basin with a drainage area of 26.5 square miles. Comparative thalweg profiles for Site 3 are shown in Figure 32. The surveyed thalweg slope for 1992 was 0.0009, and was surveyed as 0.0011 in 1993. Only minor differences in the thalweg profiles are shown except that the downstream 1,000 ft of the 1993 profile indicates approximately 2 ft of incision. Comparison of survey cross sections indicated an increase in channel volume, substantiating that some incision is occurring.

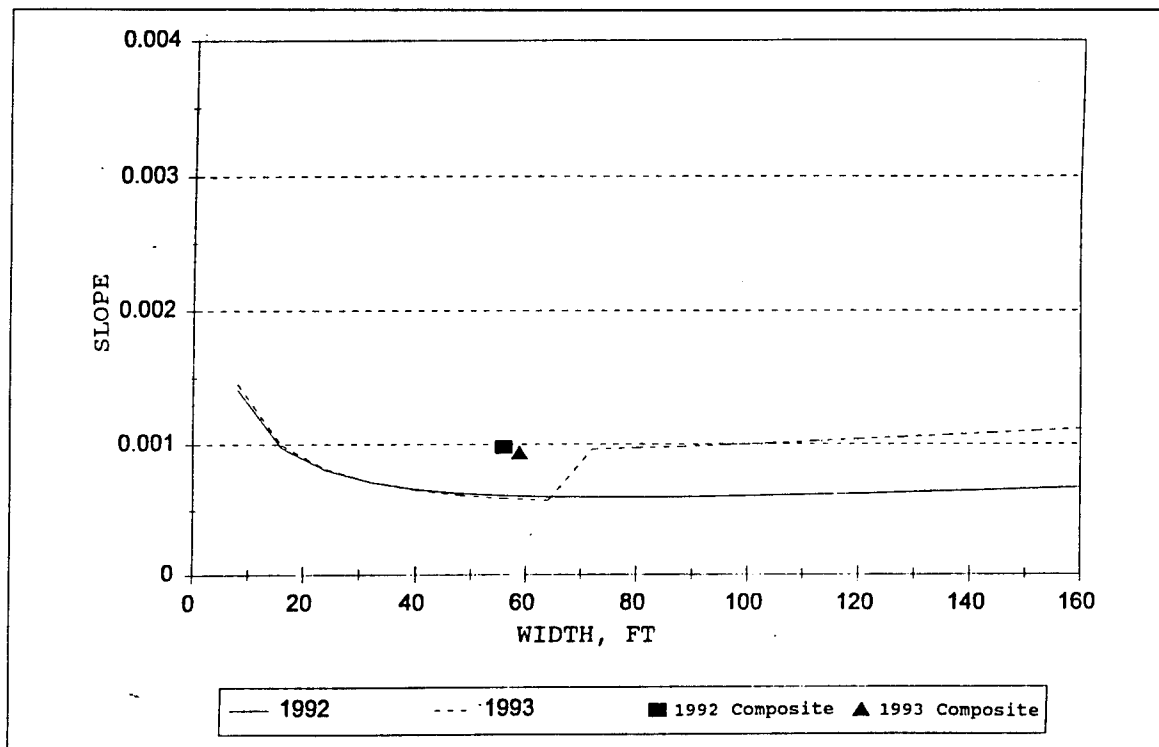
Figure 33. Comparison of 1992 and 1993 stable channel computations for Abiaca Creek, Site 3

Figure 33 is a comparison of stable channel computations for the site. The two data points represent the 1992 and 1993 composite cross sections developed from HEC-2 runs of the bank-full discharge at a total channel roughness of 0.035. The 1992 stable channel curve indicates a minimum slope of 0.0006 at a width of 76 ft, while the 1993 curve has a minimum slope of 0.00057 at 66 ft. The primary change between the two curves is that the 1993 curve shifts from upper regime (smoother) to lower regime (rougher) at about 70 ft in width. Comparing the composite data points and the stable channel computation curves presents a noticeable difference. This difference is due to the difference in estimated roughness in the HEC-2 runs and the estimated bank roughness and computed bed roughness of the SAM runs. The data suggest that the width would increase approximately another 10 ft to attain the minimum energy slope if the sediment supply remains constant. Erosion resistance of the toe of the bank may resist widening, which will result in a steeper energy gradient than 0.0006.

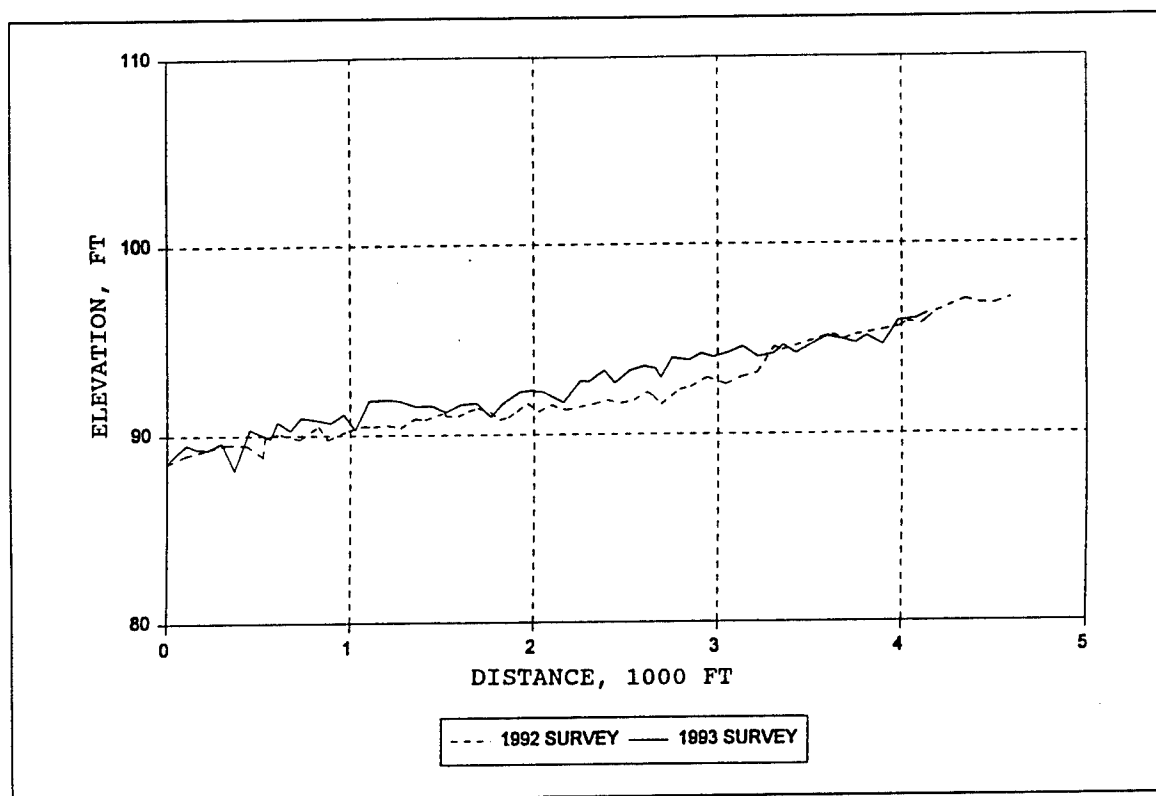
Figure 34. Comparison of 1992 and 1993 thalweg profiles for Abiaca Creek, Site 4

Site 4 extends from the confluence of Abiaca Creek and Coila Creek for approximately 4,000 ft. The upstream extent of the reach is approximately 500 ft upstream of a low timber bridge, which was apparently constructed by the local landowner or gravel miner. Depending on the amount of debris accumulation, some backwater and aggradation can exist at the bridge. Comparative thalweg profiles for Site 4 are shown in Figure 34. The surveyed thalweg slope for 1992 was 0.0017 and was 0.0016 in 1993. The 1992 thalweg indicates a break in slope approximately 3,200 ft upstream of the downstream limit, which may have been caused by debris accumulating on the low timber bridge. The 1993 thalweg indicates no break and has 2-3 ft of aggradation from 1,000 ft to 3,200 ft upstream of the beginning of the site.

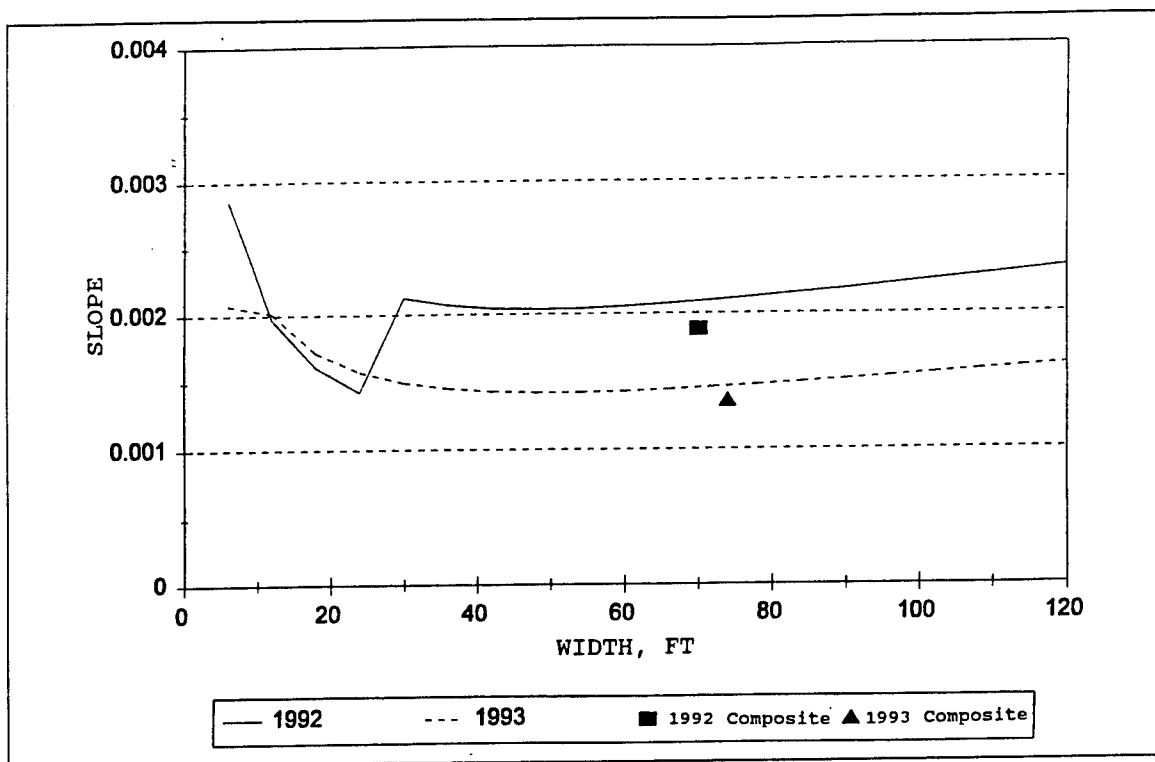
Figure 35. Comparison of 1992 and 1993 stable channel computations for Abiaca Creek, Site 4

Figure 35 is a comparison of stable channel computations for the site. The two data points are representative of the 1992 and 1993 composite cross sections developed from HEC-2 runs of bank-full discharge at a total channel roughness of 0.035. The 1992 stable channel curve indicates a minimum slope of 0.0015 at a width of only 23 ft, due primarily to the shift in roughness regime that is shown. The 1993 stable channel curve remains in upper regime throughout the full range in width, with the minimum slope occurring at 0.0014, which is almost the same as the 1992 slope, at a width of 51 ft. The data shown in Figure 35 indicate that the reach could be stable at less width and greater depth, which could result in a more desirable habitat for fish.

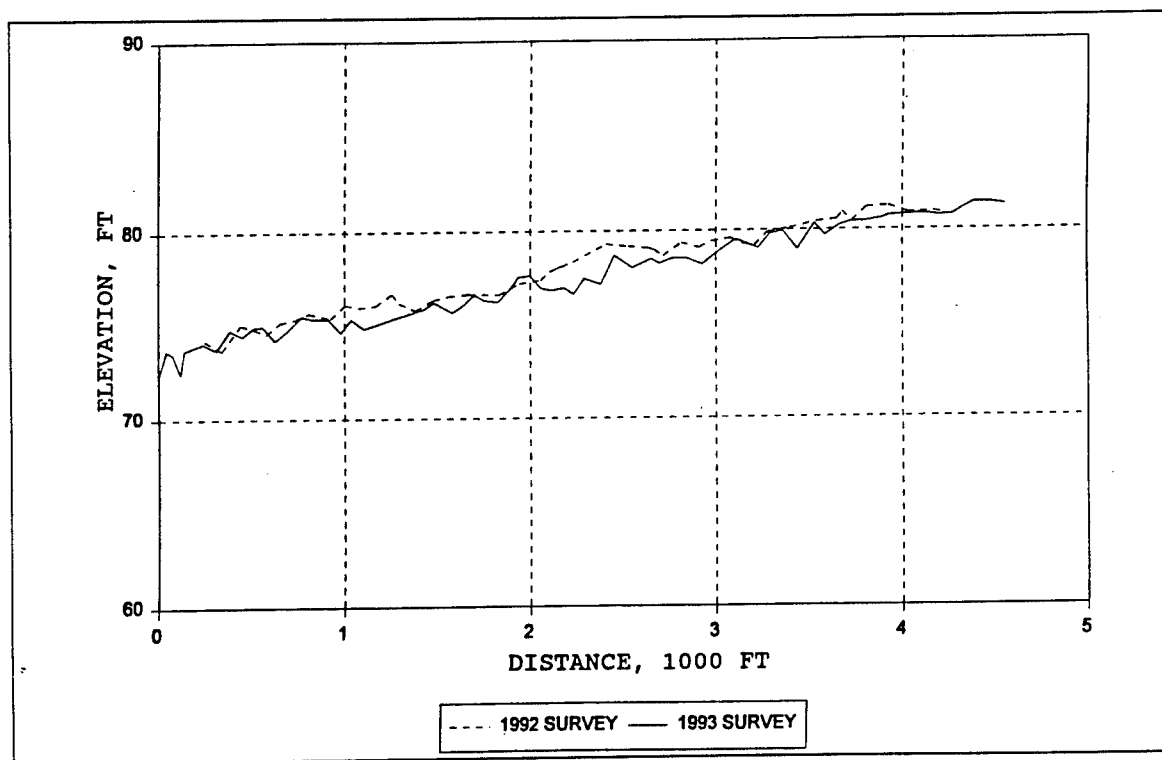
Figure 36. Comparison of 1992 and 1993 thalweg profiles for Coila Creek, Site 5

Coila Creek Site 5 extends upstream from the confluence with Abiaca Creek for a distance of approximately 4,000 ft. The study reach extends approximately 2,000 ft upstream of highway bridge 430, as shown in Figure 13. The approximately 42.1-square-mile watershed upstream of the reach had been heavily mined previously, and a high proportion of the present watershed is controlled by SCS reservoirs. Figure 36 is a comparison of the 1992 and 1993 thalweg profiles for Coila Creek. The surveyed thalweg slope for 1992 was 0.0018 and was 0.0019 in 1993. Only minor change is evident in comparison of thalwegs, with minor degradation along the channel from 1992 to 1993.

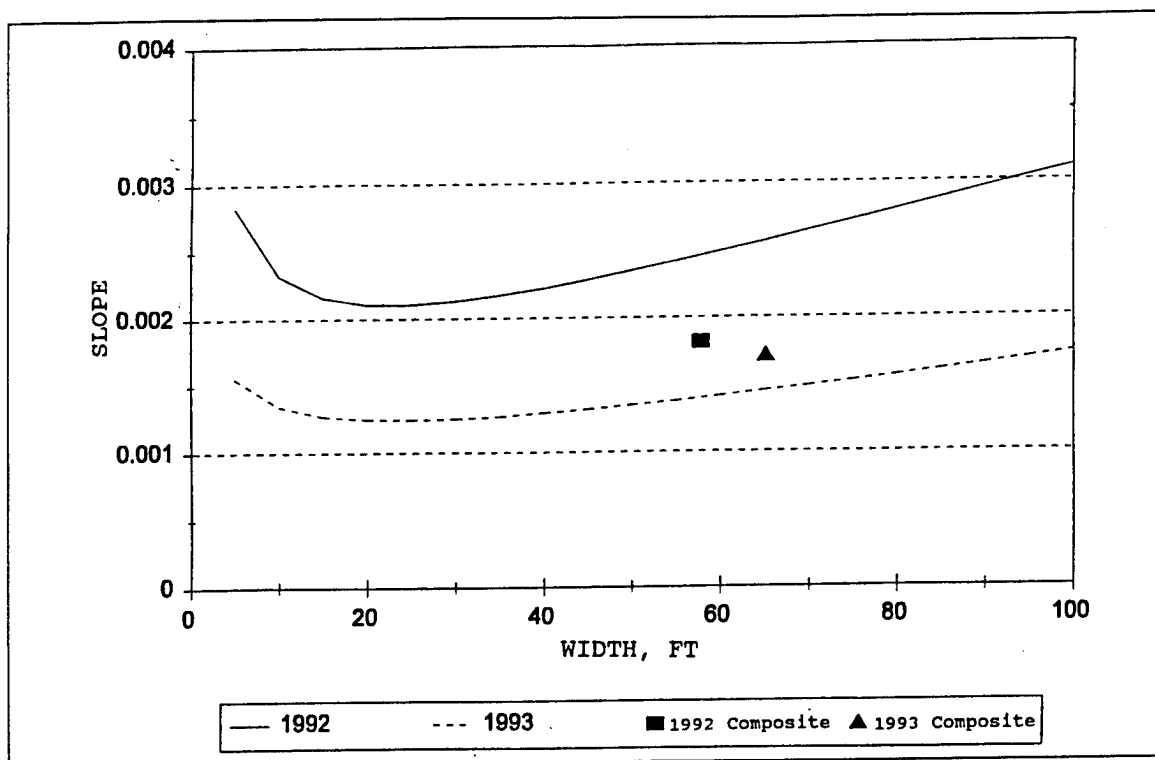
Figure 37. Comparison of 1992 and 1993 stable channel computations for Coila Creek, Site 5

Figure 37 is a comparison of the 1992 and 1993 stable channel computations for Coila Creek. The two data points represent the 1992 and 1993 composite cross sections developed from HEC-2 runs of bank-full discharge at a total channel roughness of 0.035. The 1992 stable channel curve indicates a minimum slope of 0.0021 at a width of only 23 ft. The 1993 stable channel curve indicates a similar width of 29 ft at a minimum slope of 0.0013. The predicted channel widths are three to five times less than observed widths. The variance between predicted and observed widths may be due to the lack of calibration of the Brownlie relationships for roughness and sediment transport in the gravel-size ranges of bed sediment.

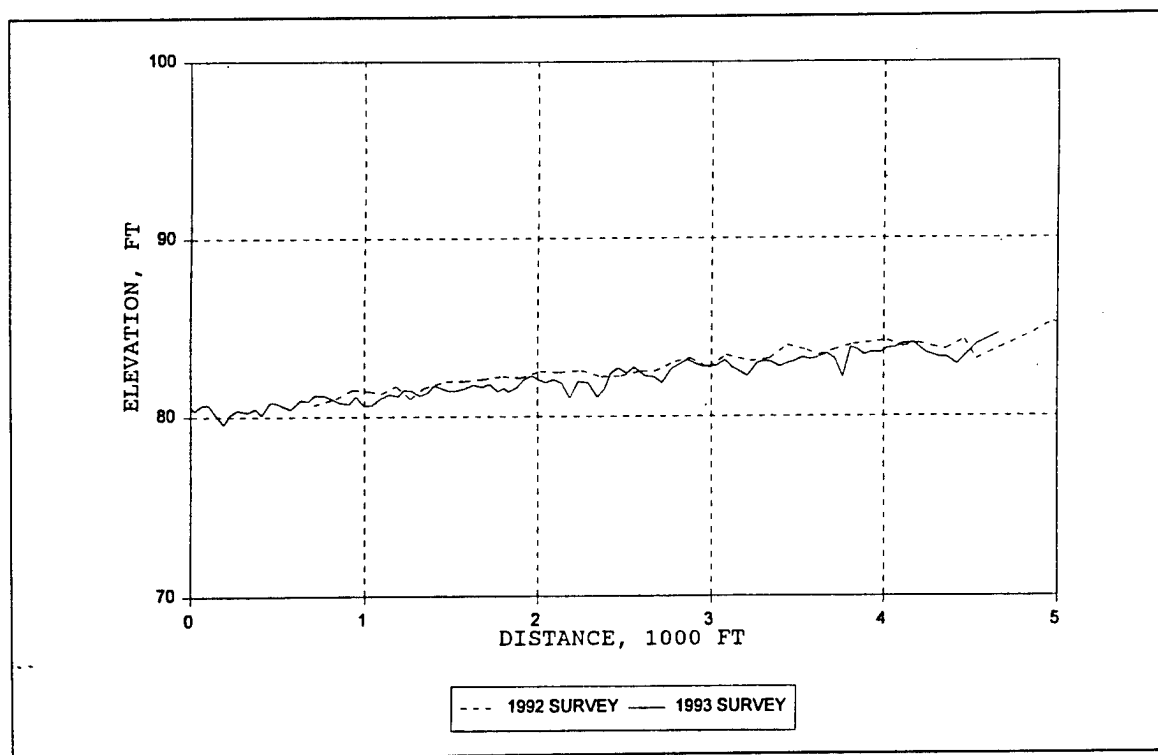
Figure 38. Comparison of 1992 and 1993 thalweg profiles for Abiaca Creek, Site 6

- Abiaca Creek Site 6 extends approximately 4,500 ft from the hill line into the flatter Yazoo River floodplain. The USGS gauging station at the bluff line is approximately 700 ft downstream of the upstream limit. The drainage area is approximately 99.1 square miles. Figure 38 is a comparison of the 1992 and 1993 thalwegs, which indicates little change between 1992 and 1993. The surveyed slope was 0.0009 in 1992 and was 0.0008 in 1993.

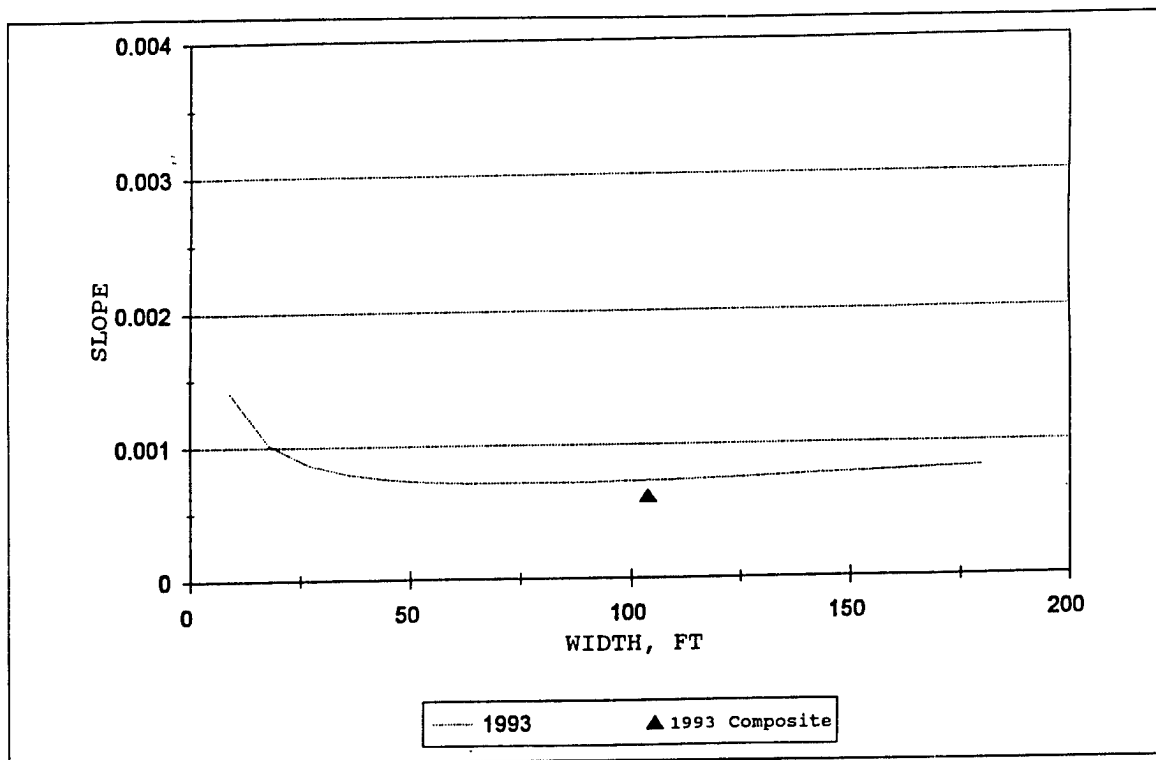
Figure 39. Stable channel computation for Abiaca Creek, Site 6, 1993

Figure 39 shows close agreement between the 1993 composite cross section computed using HEC-2 runs of the bank-full discharge and the stable channel computations. The minimum slope was computed at 0.00069 as compared with the composite slope of 0.00062. The computed width at the minimum slope was 69 ft compared with the composite 104 ft, only 66 percent of the composite; however, the stable channel curve is very flat for the reach. Very little adjustment of the site is expected without significant change in the sediment supply.

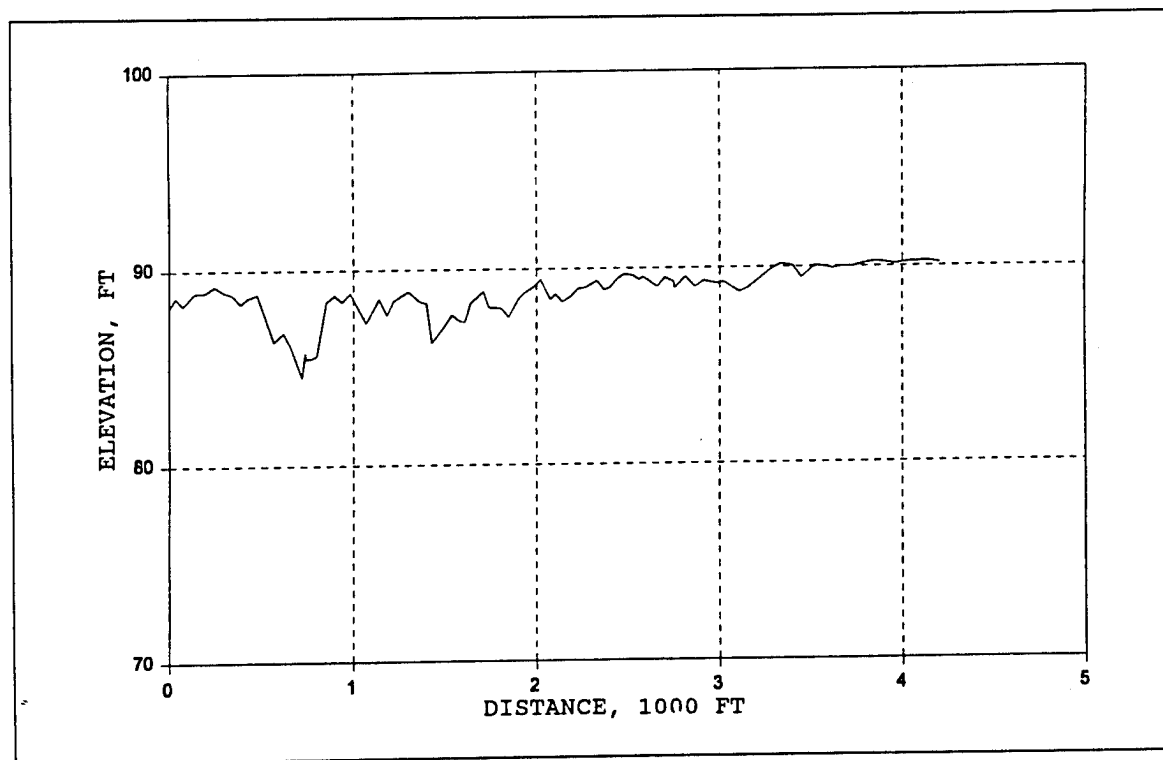
Figure 40. Thalweg profile of Abiaca Creek, Site 21, for 1993 data

Abiaca Creek Site 21 is downstream of Site 5, and is at the downstream extent of the channelized reach of Abiaca Creek at the Highway 49 and railroad bridges. This site was added in time for the 1993 surveys; no data are available for 1992. Figure 40, the thalweg profile for 1993, indicates the depth increases in the downstream portion of the reach, in the vicinity of the highway and railroad bridges. The regime width is 159 ft, the depth is 9.9 ft, and the slope is 0.00024. Time composite 1993 dimensions are 77 percent of regime width (122 ft), 91 percent of regime depth (9.0 ft), and 213 percent of regime slope (0.00051). Compared with other sites, Abiaca Site 21 is

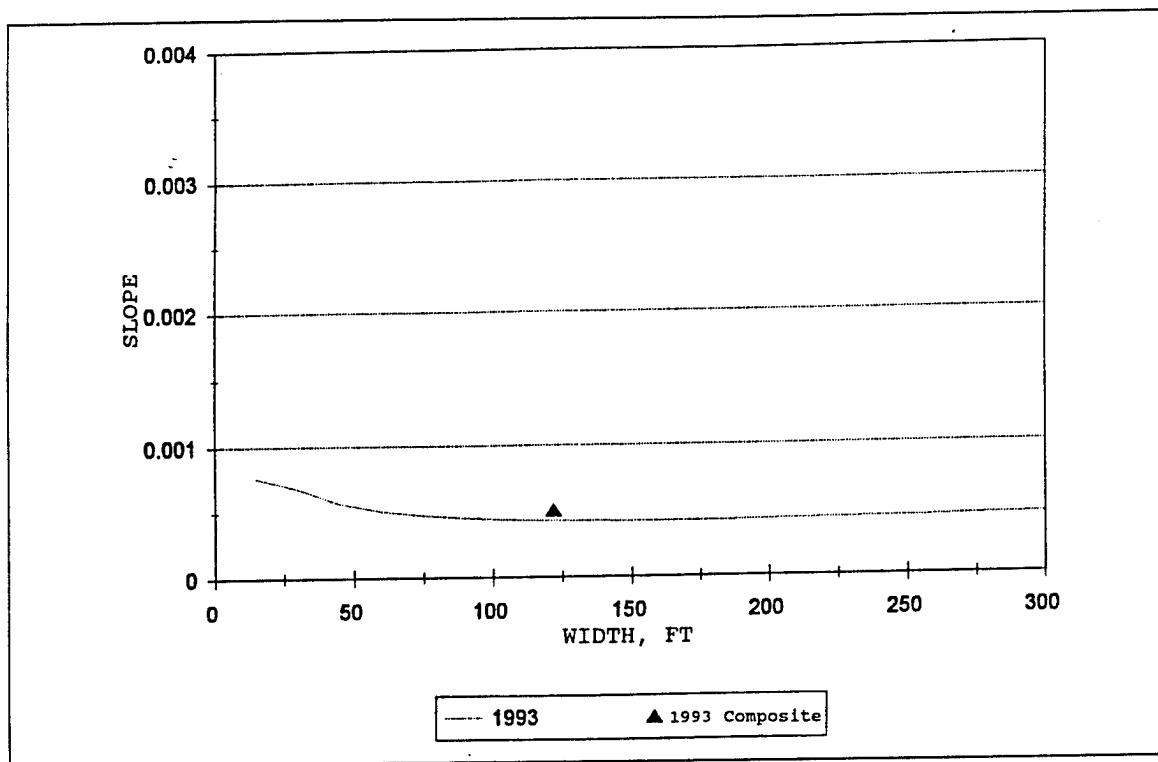
Figure 41. Comparison of computed stable channel computations for Abiaca Creek, Site 21

relatively near regime condition. Figure 41 is a comparison of computed stable channel dimensions and the 1993 composite condition. The 2-year sediment discharge is 6,414 tons/day, or 53 tons/ft/day. With the relatively low unit width sediment discharge, the close agreement of the computed stable channel curve and composite conditions is significant. The site appears to be stable for the eroding condition sediment supply at the 2-year discharge.

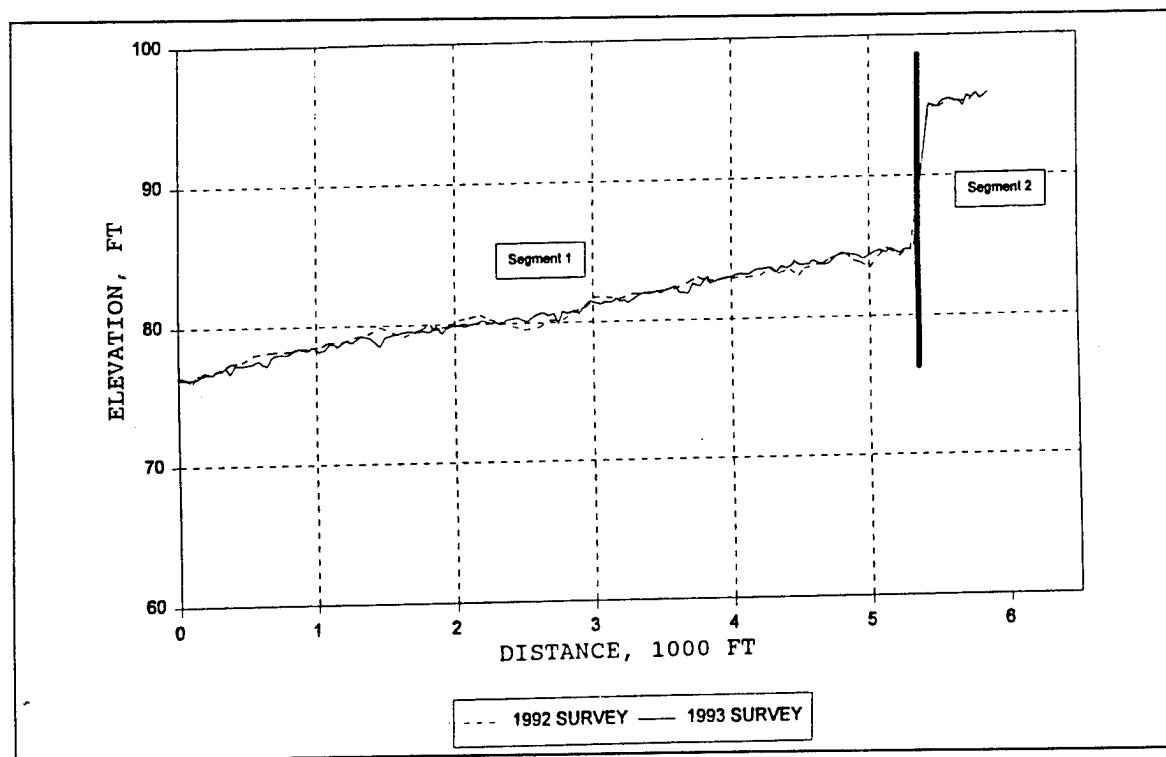
Figure 42. Comparison of 1992 and 1993 thalweg profiles for Burney Branch, Site 12

The DEC monitoring site 12 is located on Burney Branch and extends downstream from the Highway 7 box culvert through the first high-drop structure to the second structure, a distance of approximately 5,700 ft. Figure 42 is a comparison of the thalweg profiles surveyed in 1992 and 1993. The site has been divided into two segments. Segment 1 is downstream between the two drop structures, and segment two is between the upstream drop structure and the box culvert. As shown in Figure 42, no significant change occurred in the thalweg profile.

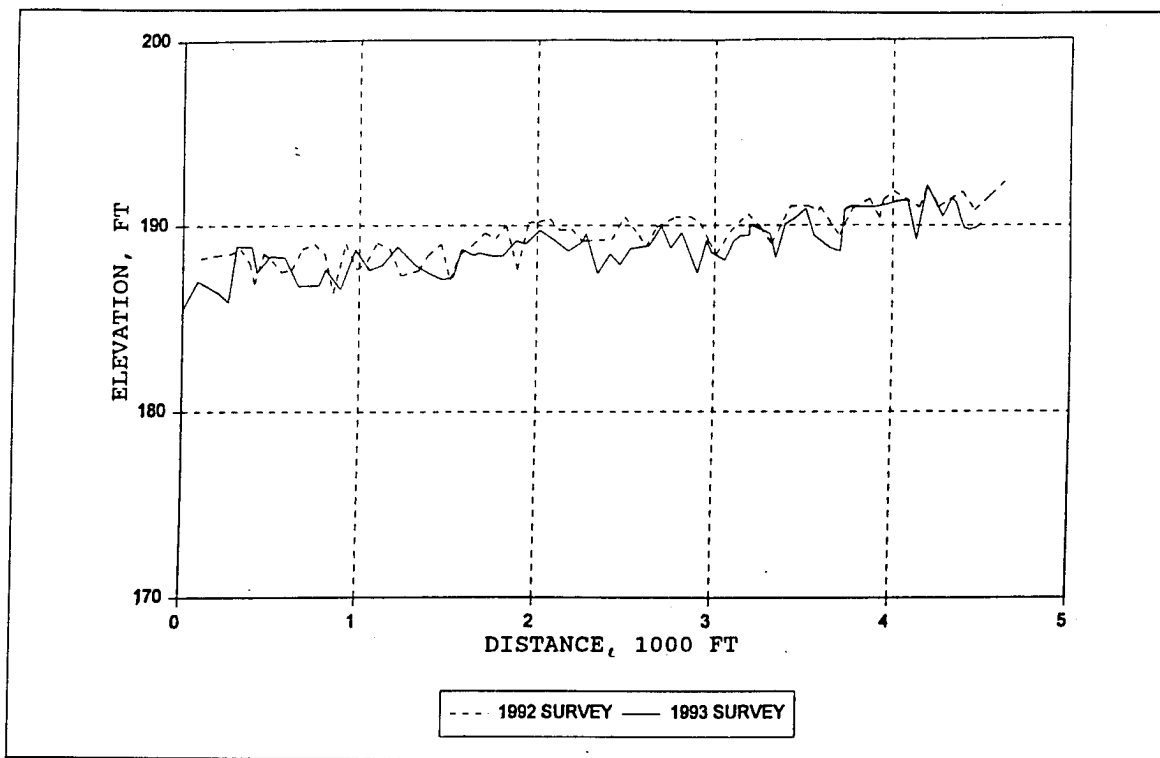
Figure 45. Comparison of 1992 and 1993 thalweg profiles for Harland Creek, Site 1

Site 1 extends approximately 2,000 ft upstream and downstream of the county road bridge near Eulogy, MS. The downstream portion of the site was riprapped following the 1992 surveys and prior to the 1993 surveys. The surveyed channel thalweg slope is the same for 1992 and 1993, as shown in Figure 45. No significant difference is apparent following the riprap emplacement; however, response may require several years.

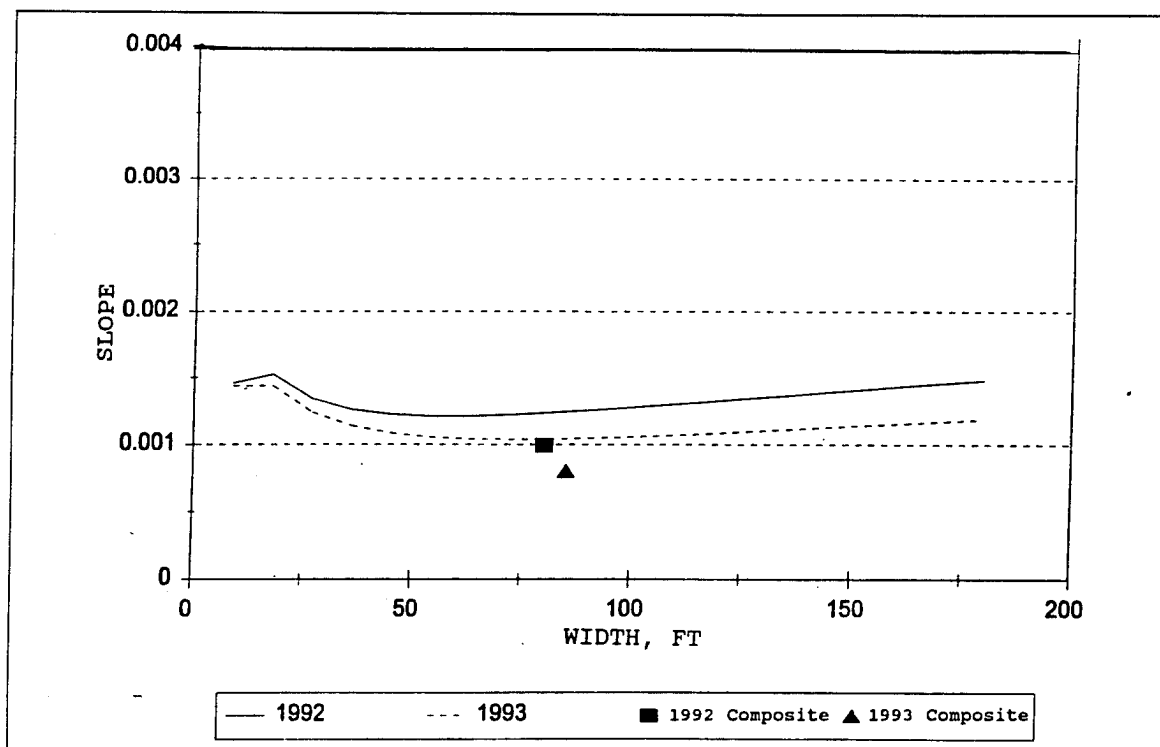
Figure 46. Comparison of SAM stable channel computations and the 1992 and 1993 composite cross section for Harland Creek, Site 1

The 2-year discharge for the reach is 3,739 cfs, and the bank-full discharge was found to be 1,970 cfs, about 53 percent of the 2-year. Table 5 summarizes the analyses developed for the reach. Although the bed slope of the reach has not changed, the 1993 channel composite section was wider, slightly deeper, and about 20 percent flatter than the 1992 composite section. The 1993 section is approaching regime width and depth. The lower portion of the reach may respond to the bank stabilization by becoming deeper and narrower; however, with continued sediment supply from upstream and tributaries, the response may be masked. Computations using the Brownlie sediment transport function indicate that the bank-full sediment transport capacity decreased approximately 30 percent between the surveys. Figure 46 compares the stable channel computation results and the composite cross-section data.

The relationship of the two data sources indicates that the reach is mildly aggradational; however, the hydraulic roughness used in the computations could not be calibrated. The composite width is greater than the computed stable channel width.

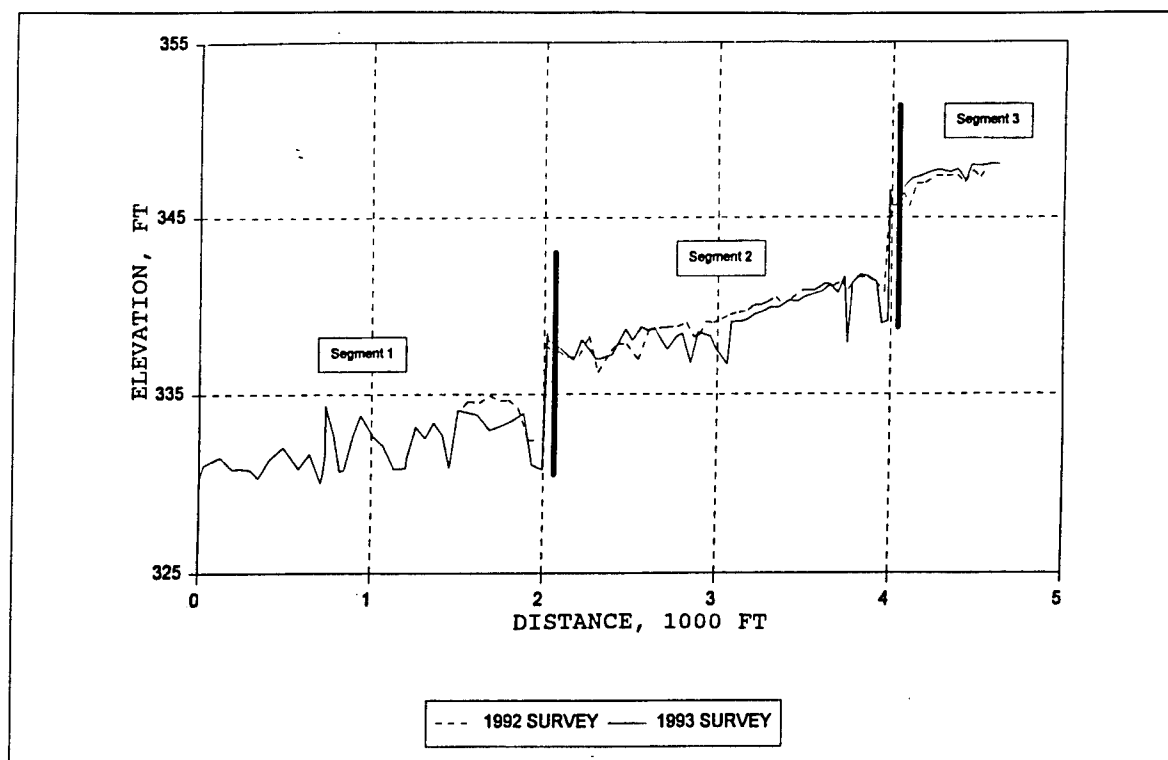
Figure 47. Comparison of 1992 and 1993 thalweg profiles for Hickahala Creek, Site 11

Hickahala Creek, Site 11, extends for approximately 4,000 ft, encompassing two low-drop structures, the lower structure being completed in 1992. The 2-year discharge is 2,158 cfs, and the bank-full discharge is 1,290 cfs, about 60 percent of the 2-year. Three reaches are defined by the two structures as shown in Figure 47, a comparison of 1992 and 1993 thalweg profiles. In addition to the two structures shown, a third structure was recently completed on South Fork, Hickahala Creek, which is a tributary to the study reach in segment 2. Segment 3 has been relatively stable with some bank erosion at the outside of the bank in the approach to the upstream drop structure. Portions of segment 1 and segment 2 exhibit incision and bank failure and a wide variance in channel depth. Segment 2 has not yet completely responded to the structure construction, both on the main channel and the tributary.

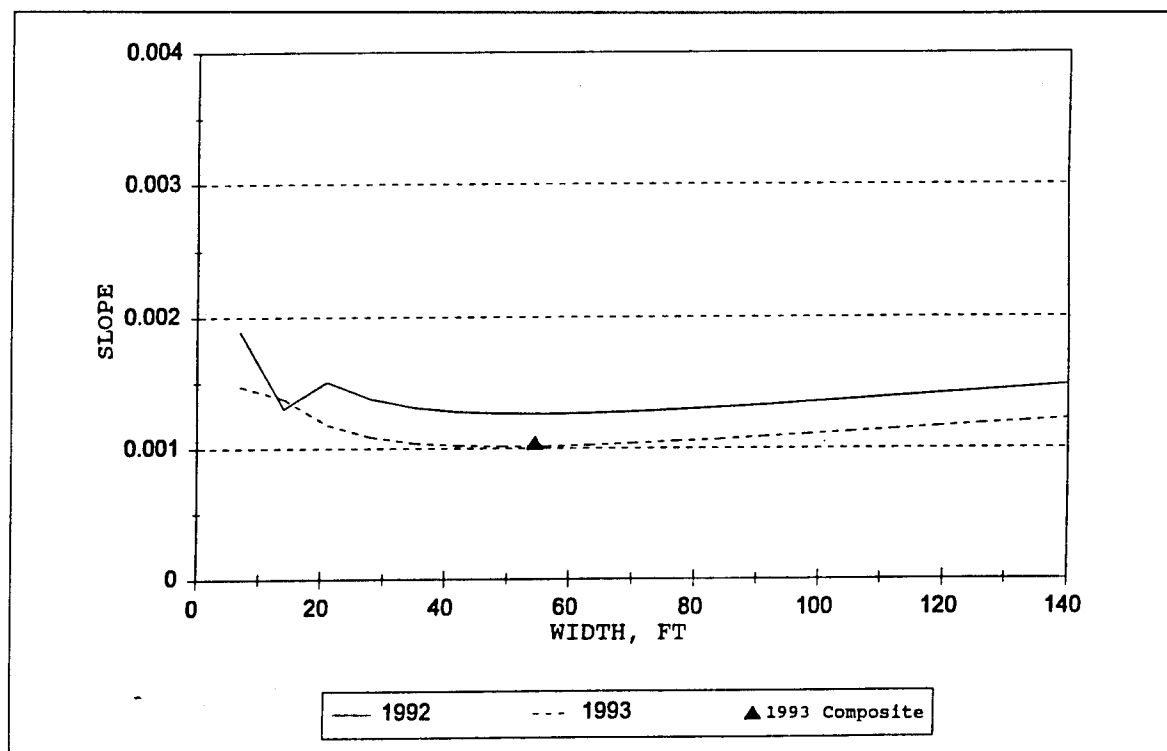
Figure 48. Hickahala Creek (Site 11), segment 1, stable channel and composite section comparison

Figures 48, 49, and 50 are comparisons of 1992 and 1993 stable channel computations and composite sections for segments 1, 2, and 3, respectively. Although the composite channel width in segment 1 is much less than the regime width, good agreement exists for the 1993 stable channel computation and the composite section. Figure 49 indicates that segment 2 is predicted to be degradational for the 1993 data, and was observed to be unstable. By comparison, the 1993 data for segment 3 is much more unstable. The channel is responding dramatically to preconstruction incision and to the structure construction. Particular attention will be paid to the segment 3 response to ascertain re-incision tendency.

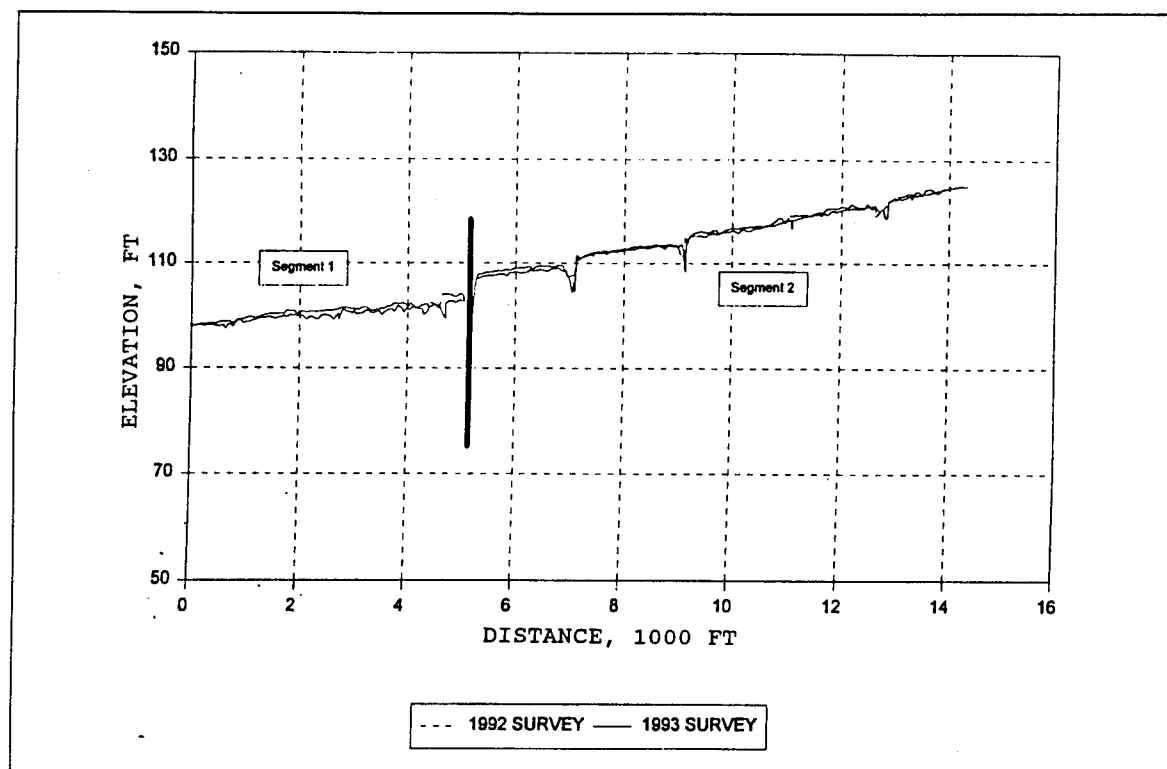
Figure 51. Comparison of 1992 and 1993 thalweg profiles for Red Banks Creek, Site 9

Red Banks Creek, Site 9, is located in the Coldwater River Basin in Watson, MS. The site extends for approximately 14,000 ft upstream of the Watson-to-Moscow Highway and is divided into two segments as shown in Figure 51. Segment 1, the downstream segment, extends from the highway bridge upstream for a distance of 5,000 ft to the most downstream of four chevron weirs constructed by the Vicksburg District. Segment 2, the upstream segment, encompasses the upstream chevron weirs and is about 9,000 ft in length. The chevron weirs are unique structures among the DEC monitoring sites, and appear to be effective in raising the bed of Red Banks Creek by aggradation. The weirs are shown in Figure 51 at locations of 5,000, 7,000, 9,000, and 13,000 ft upstream of the bridge. Most of segment 2 has a riprap toe emplaced along both banks. Segment 1 has some bank stabilization and does not have any grade control. At the bridge, a combination of low stone dikes connected at the riverward extent has worked effectively in aligning the stream with the bridge right of way and narrowing the channel. The drainage at the study site is 27.8 square miles, and the 2-year discharge is 3,951 cfs, which flows within bank. The bed slope in 1993 for segment 1 was surveyed to be 0.0009, and segment 2 was surveyed to be 0.0018. The bed material is characterized as medium sand ($D_{50} = 0.5$ mm). The channel bed slope is relatively flat; loose sediment depth is greater than
